## Shattered Windscreen Glass Replacement

2018

[www.rusalka.com.au](http://www.rusalka.com.au)

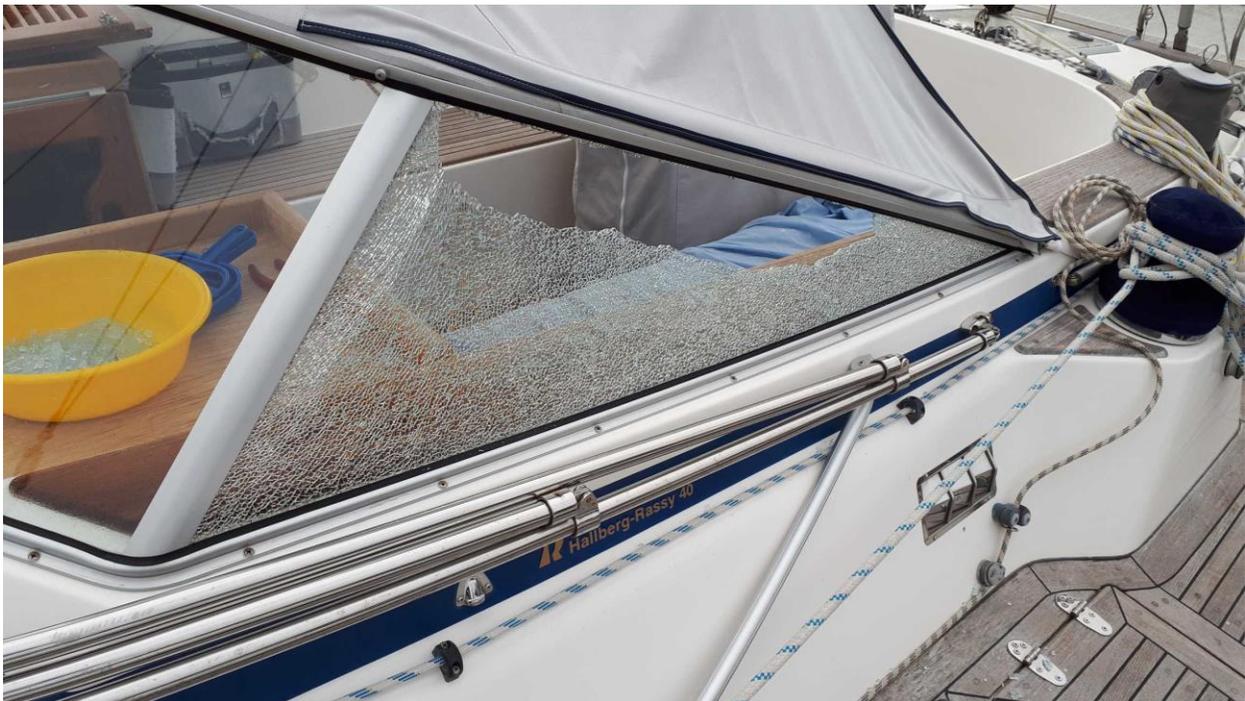
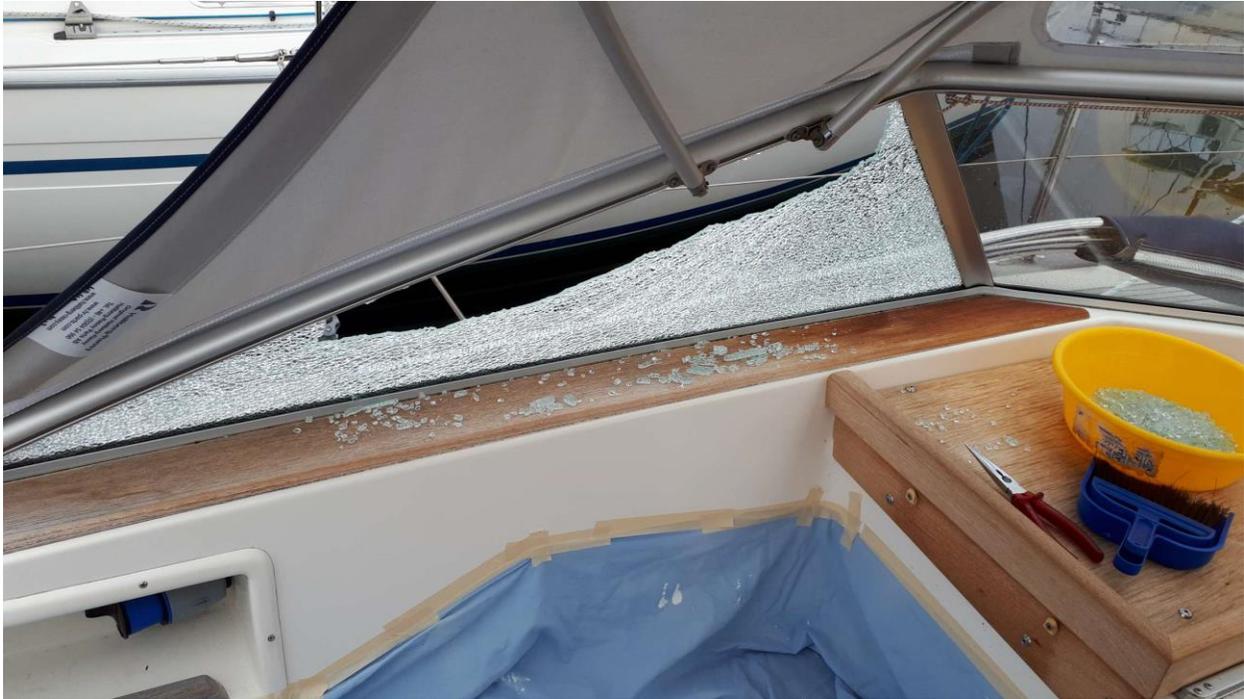
I came to the marina one morning and saw the aft port window pane of the windscreen shattered. The pane was still all together, no holes in it. It was all shattered and still in place. The handle was neatly mounted in the shattered pane.

*The shattered glass pane after handle was simply taken off*

Hallberg-Rassy forums talk about these windscreens shattering spontaneously. The glass is toughened glass and is subject to nickel sulphide impurities, inherent in the manufacturing process. The toughened glass, sometimes called tempered or heat treated, is under stress in the frame, in fact it is slightly curved to fit in. It is this impurity while under stress that can cause the glass to shatter, for no apparent reason, even years after manufacture.

The glass was removed, including the glass chips in the grooves of the frame. The outside rubber seal along the top and bottom frames was carefully pulled off and saved for reuse. A caliper measurement confirmed it was 5mm glass. Initially the black adhesive was left in the grooves.

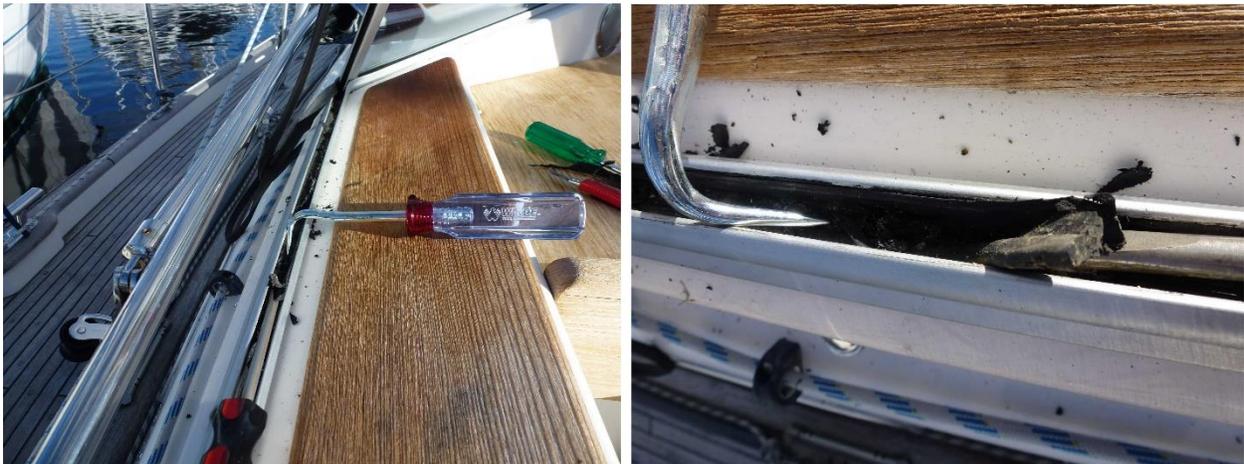
*Cleaning out the shattered glass*

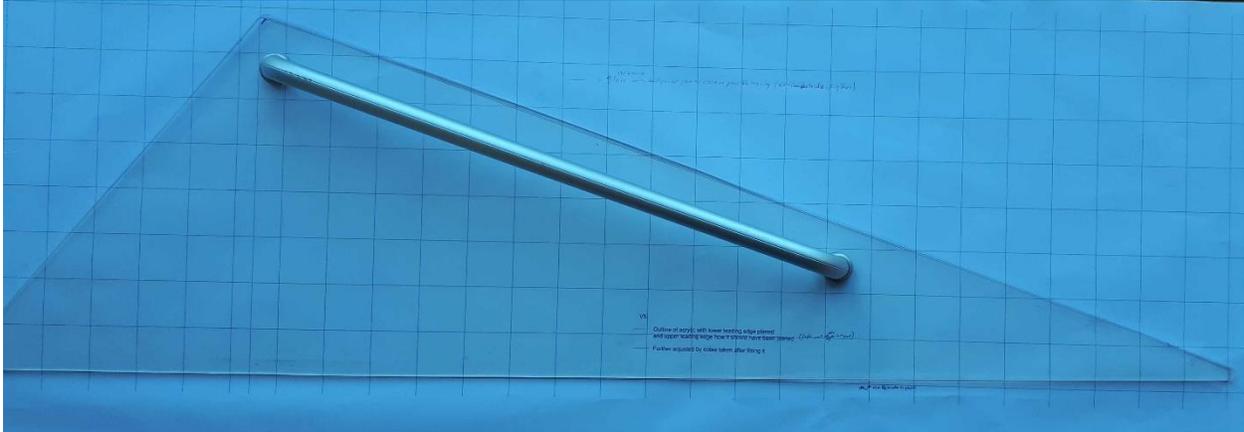
*Acrylic window used as a template plus final trim corrections to trace/sketch then enter into computer to generate manufacturing file*

Careful measurements around the acrylic and into the frame grooves were noted for later corrections. The shape of the acrylic was traced out onto gridded paper and the final fine corrections were added.

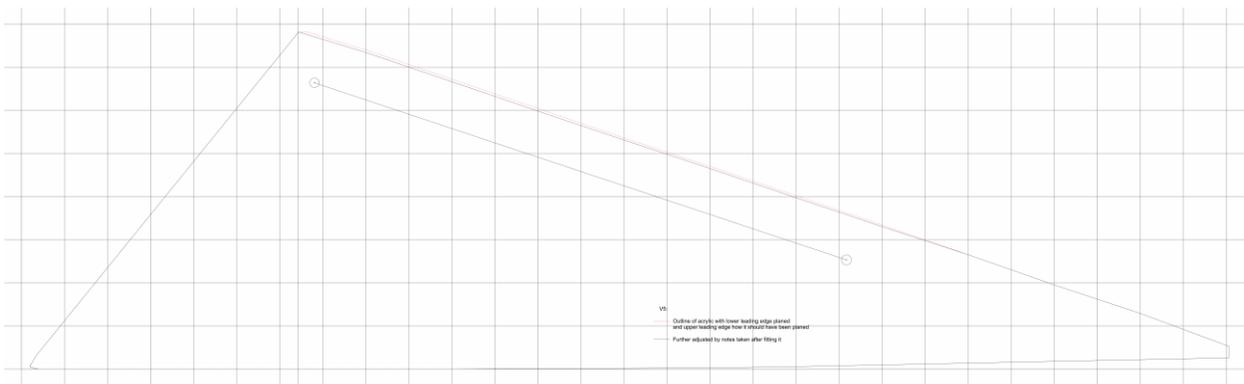
*Plot of dxf file sent to glass manufacturer*

The tracing was placed over a grid, carefully measured manually and drawn into a computer file. The file was saved as a .dxf (standard Drawing Exchange Format file). This file was sent to a local glass manufacturer who produced the required 5mm toughened glass.

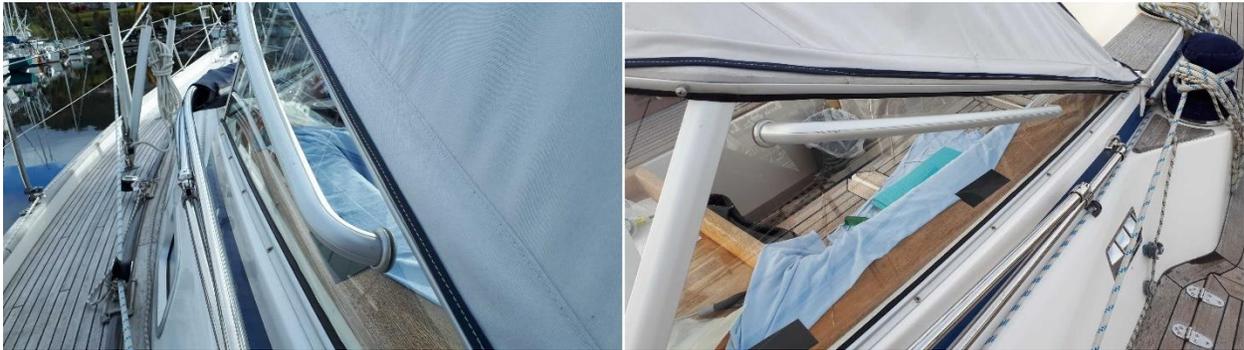
*The new toughened glass pane fitted - note its slight curvature as it was slightly bent to fit into the curve of the aluminium frame*

The frame grooves were injected with adhesive. On the bottom and top frames it was mainly applied on the cockpit side of the frames. The outside needs to be kept free enough of adhesive so that the rubber seal strip can be pressed in afterwards without touching it. The forward frame groove is narrower and adhesive was applied into it as best as could be done.

The adhesive used was an SMP type, in this case Selleys SolarFlex.

To fit the cardboard/acrylic/glass into the frame the screw at aft end, holding down the top of the frame has to be removed. The frame is then opened. The screws along the bottom frame can be removed to help to further open up the frame. The cardboard/acrylic/glass can be forced to bend to when fitting. It is extremely important to not scratch or chip the toughened glass.

The rubber chips in the grooves are there to ensure the glass is not fitted against the aluminium frame. The groove in the forward frame is the same width as the glass thickness and has no rubber chips, so the glass is going to be held against the metal. As long as the glass is not against the other frames this should not be an issue.
